11 Problems – 11 Solutions

Case Histories of 11 Machinery Vibration Problems – Part 2

Kevin R. Guy, Delaware Analysis Services, Inc., Francisco, Indiana

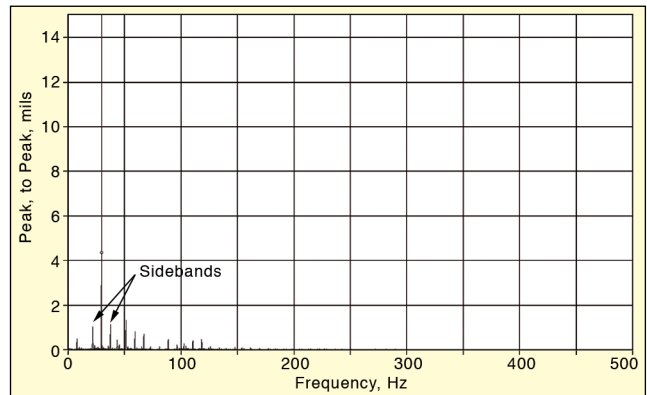
Symptoms – Data collected, by the plant vibration monitoring contractor, indicated high 1× vibration and sidebands spaced at ± 7.98 Hz (Figures 22 and 23). Axial vibration amplitudes at times exceeded 15 mils_{pk-pk}. Axial vibration increased as the inlet damper opened. Vibration in the axial direction became high enough that it destroyed the proximity probe installed to measure the shaft thrust. An overview of the data indicated shaft vibration as much as five times higher than the seismic vibration.

Figure 22. Inboard fan bearing cap vibration – axial.

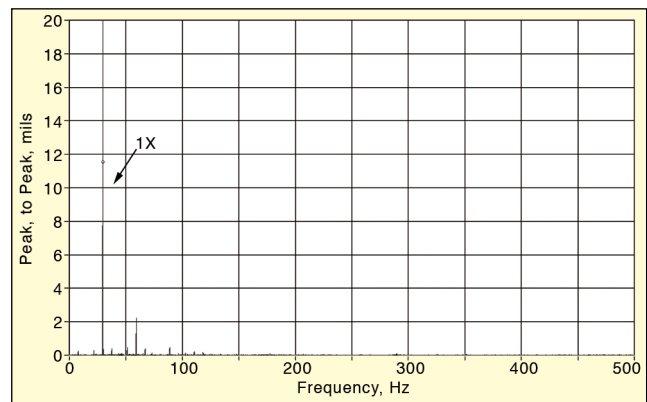
Figure 23. Inboard fan shaft vibration – horizontal.

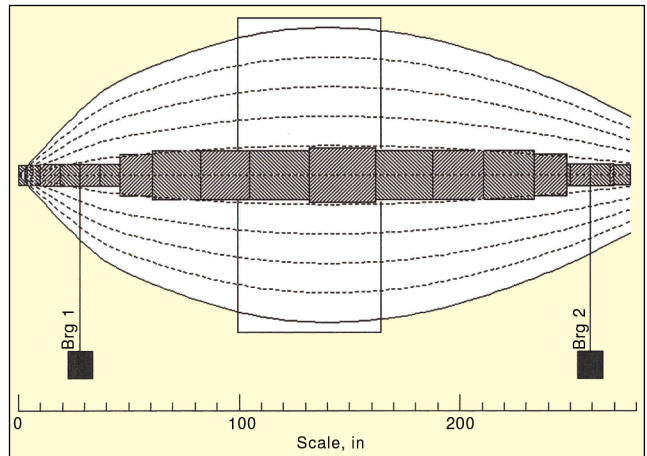
A rotor dynamic model was developed from the generated data (Figure 39). This model calculated a shaft critical speed of 836 rpm (Figure 40) which correlates with the balance sensitivities and lag angle changes seen in Figure 35. These data were provided to the fan manufacturer to utilize when designing a new fan. It was also requested to balance the fan to the API balancing specification of $2W/n$. Additionally, the plant requested that the new fans be supplied with dual proximity probes on each bearing. A keyphaser was also required.

Figure 39. Rotor dynamic model installed fan.

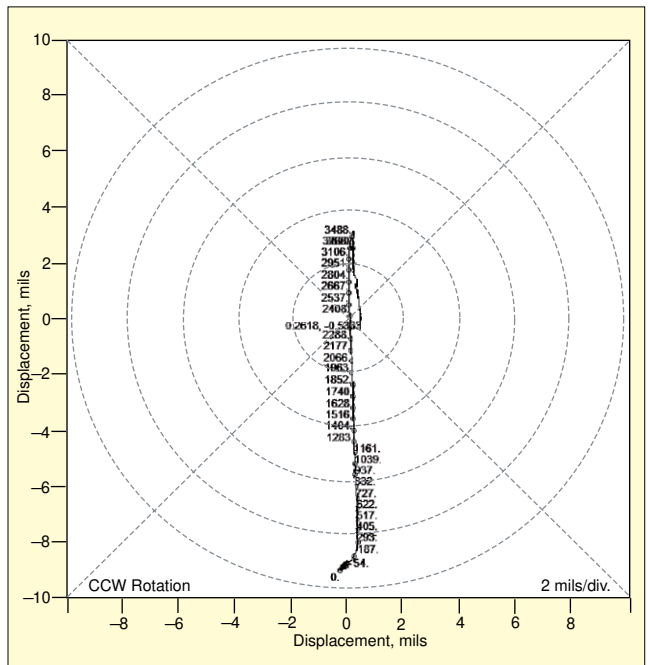
Figure 49. Bearing #1 centerline plot.

reaches operating speed. This is normal (Figure 49). Bearing #2 starts very low and then rises as the bearing is loaded (Figure 50). This heavy load causes the bearing temperature to run above 210° F. Bearing #3 starts above the centerline and operates above the centerline in the unloaded condition (Figure 51).

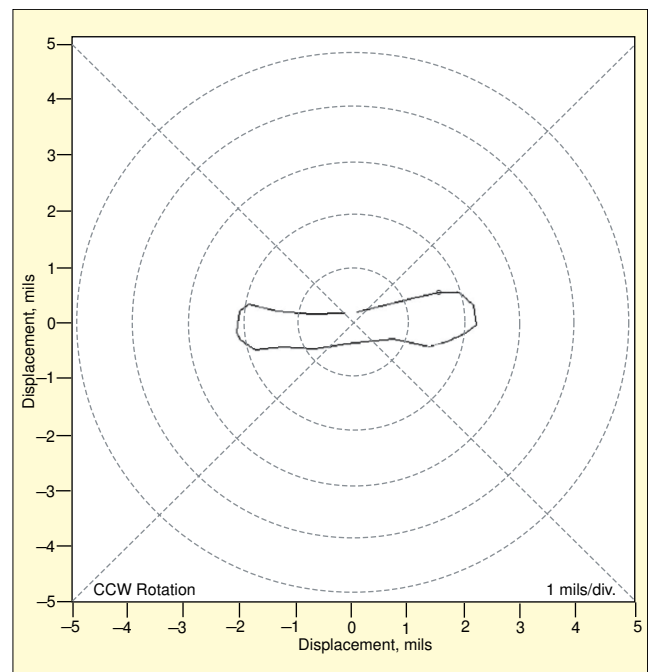
Figure 54. Bearing #1 orbit.

Orbit data from all bearings are not a true elliptical orbit. Bearing #1 (Figure 54) shows a very flat orbit. This orbit should be elliptical from the top right to the bottom left due to the counterclockwise rotation of the shaft. Centerline plots show the shafts sitting in the upper half of the bearings (Figure 55).

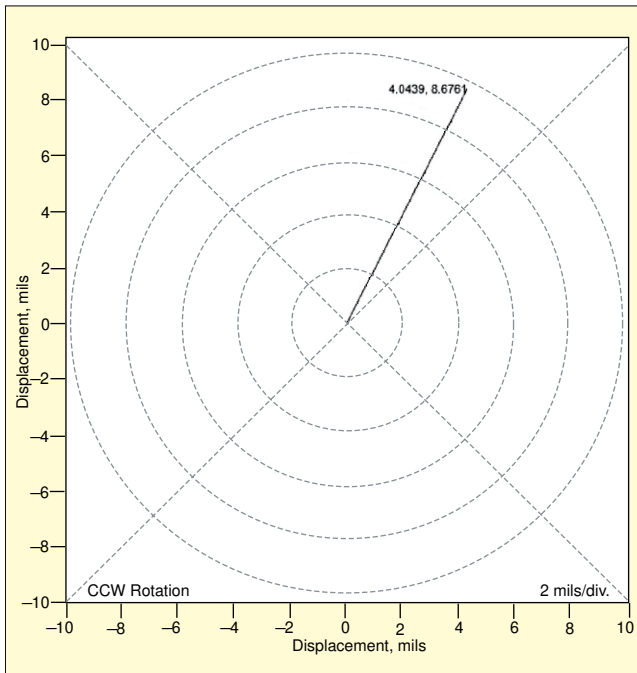
Figure 55. Bearing #1 centerline plot.
