11 Problems – 11 Solutions

Case Histories of 11 Machinery Vibration Problems – Part 2

Kevin R. Guy, Delaware Analysis Services, Inc., Francisco, Indiana

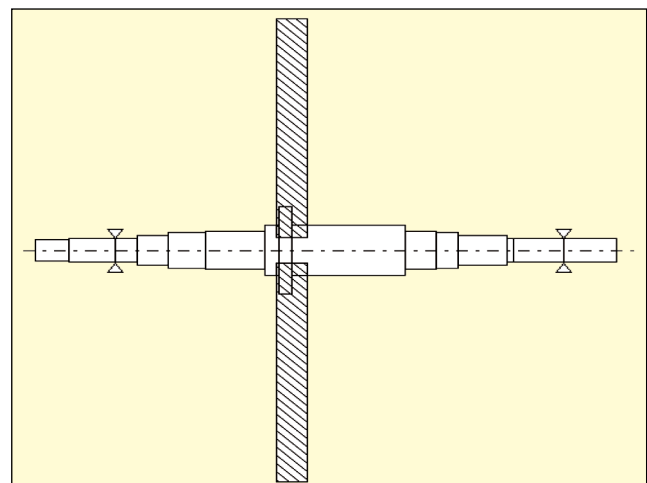
Figure 24. Rotor layout for model.

Test Data and Observations – Because of the increase in vibration, in the axial direction, when the inlet damper opened it was decided to first look into the possibility of a natural frequency problem with the fan. A rotor dynamic model was developed from fan engineering drawings to look for a critical speed issue. The rotor layout is shown in Figure 24. The first mode shape is shown in Figure 25 and the critical speed map in Figure 26. The first critical speed was found to be 3222 rpm (53.7 Hz). The critical speed data indicate this fan was running well below the first critical speed.

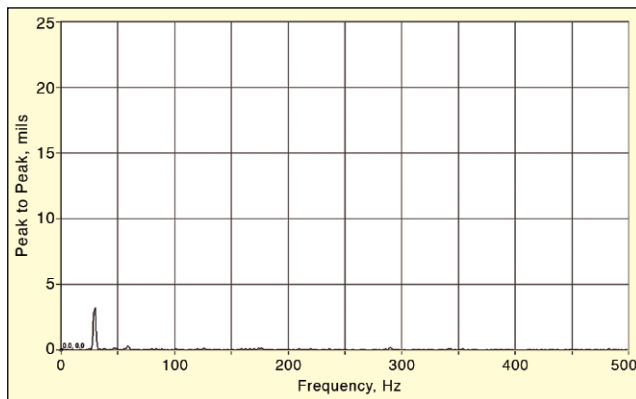
Figure 31. Inboard fan bearing proximity probe – low amplitude.

Test Data and Observations – Initial vibration data, while appearing stable, was not. The data, trended over time, showed the vibration amplitude increase with time (Figures 29-31). Figure 33 shows a coast down. The coast down and vibration trend are classic indications of a rub condition.

The fan still had a significant vibration after this inspection. In fact it was impossible to tell the difference between the data from before and after the inspection.

Corrective Actions – It was recommended the fan be shutdown and inspected for a rub. Since this fan was just overhauled, the rub was most likely caused by a shaft seal. Additionally, it was recommended that the alignment be checked to find out if the vertical alignment was off and possibly causing the rub.
